Test Report For:
ANSI/BIFMA X5.9-2012
Storage Units

FastenLink

ANSI / BIFMA X5.9-2012 Storage Units

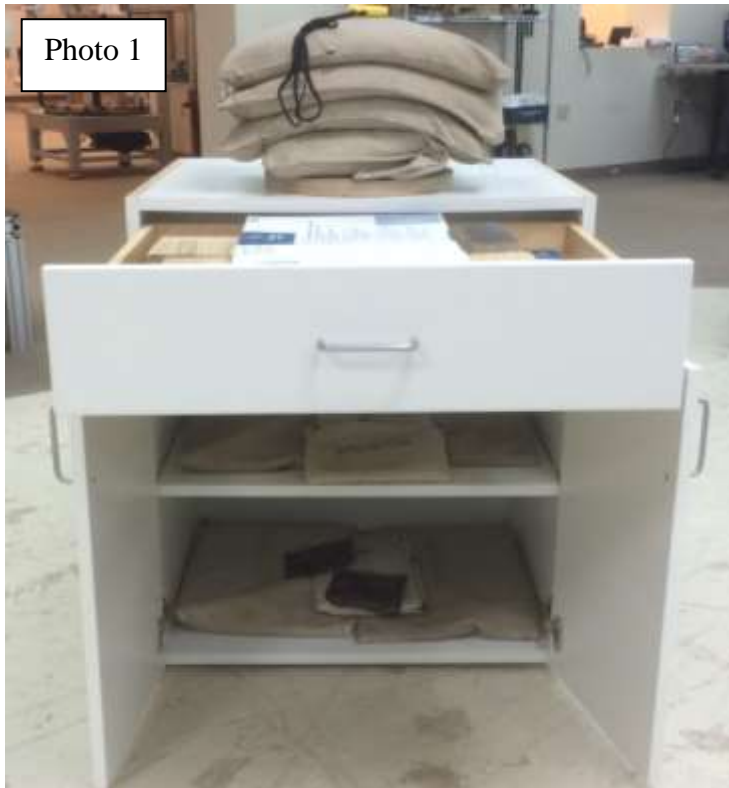
- Temperature / Humidity: 71⁰F / 32 RH%.
- Refer to page 3 for specified loads.
- A 200 lb. load was applied through a 12 inch disk, 1 inch from the unit edge at the weakest position on the primary surface.
- All remaining surfaces and elements were loaded with their distributed functional loads; the extendible element as fully extended.
- Loads remained for 60 minutes.
- See Photo 1 for set up.

Specimen	Unit Load (lbs.)	Time (min.)	Pull Force (lbs.)	Observation
2	454.7	60	< 11.2	No loss of serviceability.

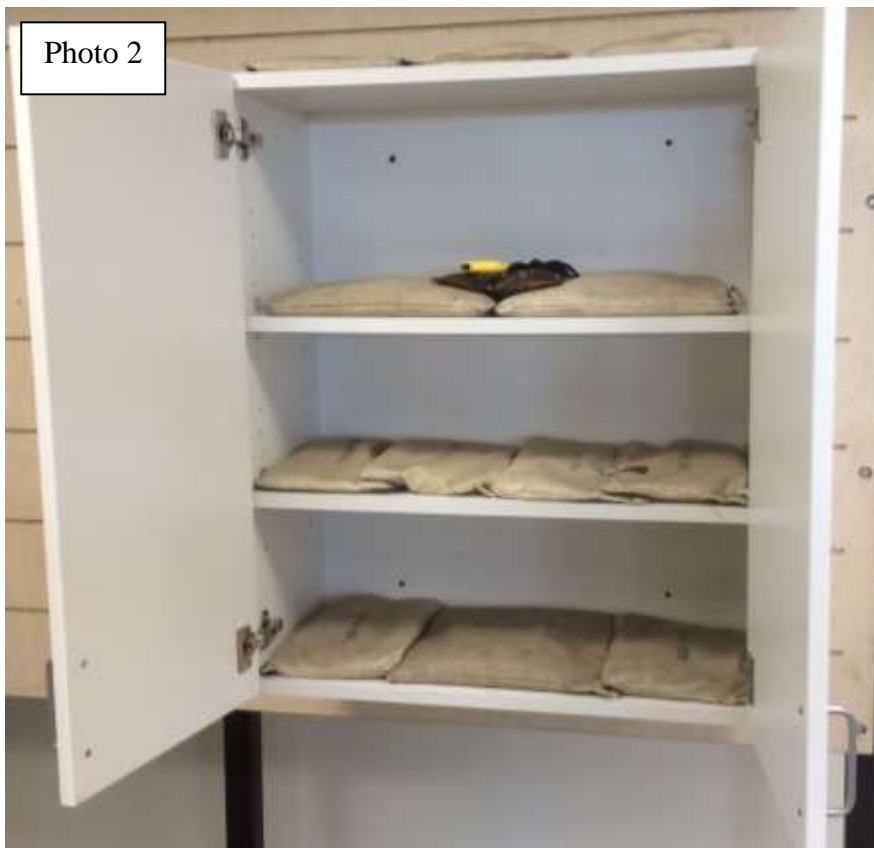
- Temperature / Humidity: 72⁰F / 28 RH%.
- Refer to page 3 for specified loads.
- The distributed functional load was evenly distributed along a line 8 inches in around the perimeter on the primary surface.
- All remaining surfaces and elements were loaded with their distributed functional loads.
- Loads remained for 60 minutes.
- See Photo 2 for set up.

Specimen	Unit Load (lbs.)	Time (min.)	Pull Force (lbs.)	Observation
1	168	60	NA	No loss of serviceability.

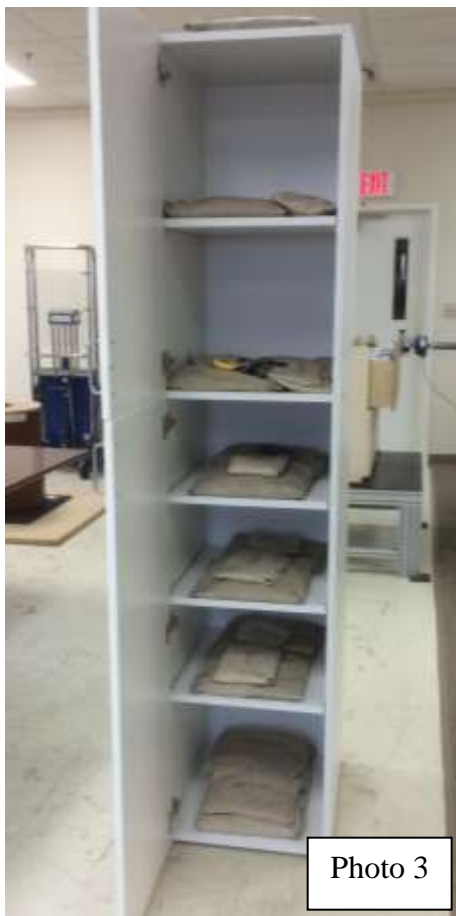
- Temperature / Humidity: 72^oF / 42 RH%.
- Refer to page 3 for specified loads.
- The distributed functional load was evenly distributed along a line 8 inches in around the perimeter on the primary surface.
- All remaining surfaces and elements were loaded with their distributed functional loads.
- Loads remained for 60 minutes.
- See Photo 3 for set up.

Specimen	Unit Load (lbs.)	Time (min.)	Pull Force (lbs.)	Observation
3	420	60	NA	No loss of serviceability.

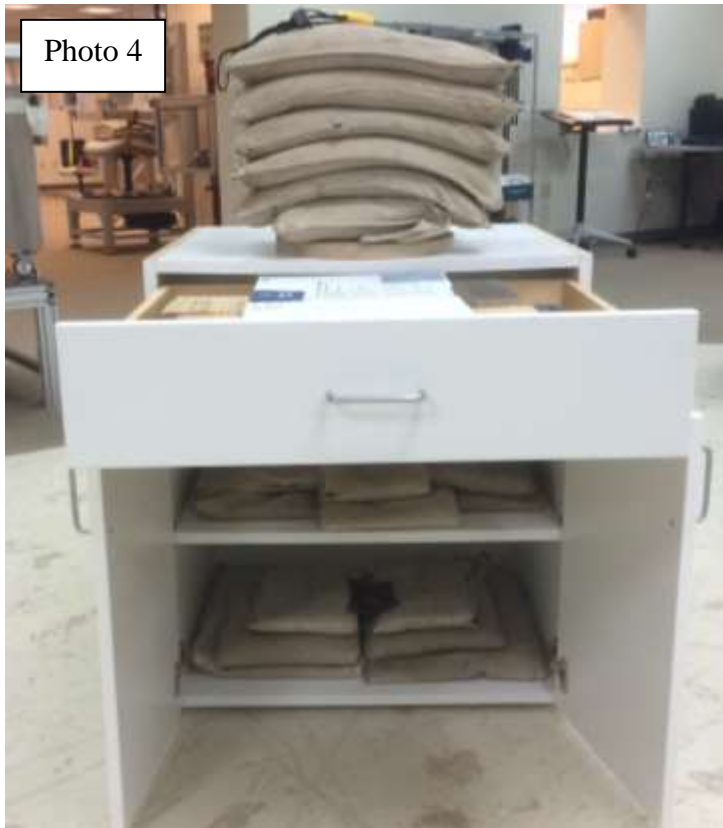
- Temperature / Humidity: 71⁰F / 32 RH%.
- Refer to page 3 for specified loads.
- A 300 lb. load was applied through a 12 inch disk, 1 inch from the unit edge at the weakest position on the primary surface.
- The extendible element remained loaded with the distributed functional load and fully extended.
- All remaining surfaces were loaded with their distributed proof loads.
- Loads remained for 15 minutes.
- See Photo 4 for set up.

Specimen	Unit Load (lbs.)	Time (min.)	Observation
2	672.7	15	No sudden and major changes.

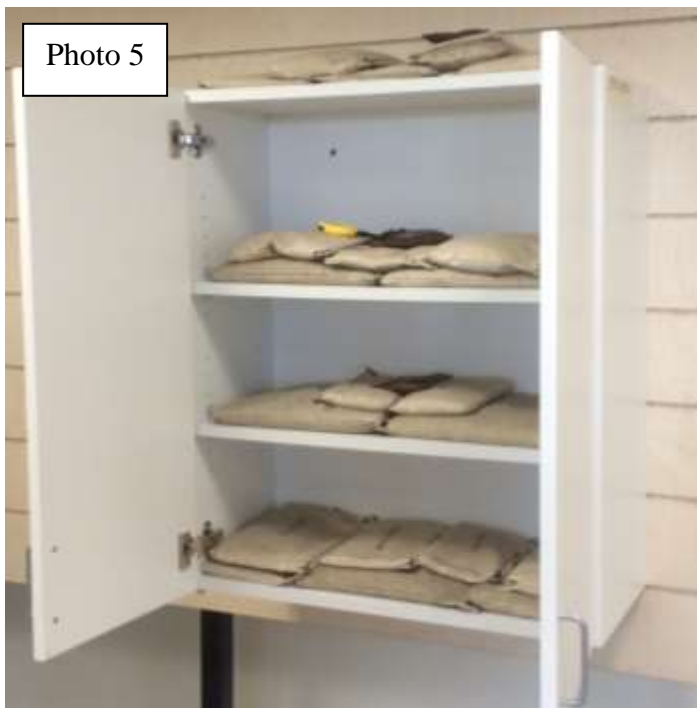
- Temperature / Humidity: 72⁰F / 28 RH%.
- Refer to page 3 for specified loads.
- The distributed proof load was evenly distributed along a line 8 inches in around the perimeter on the primary surface.
- All remaining surfaces were loaded with their distributed proof loads.
- Loads remained for 15 minutes.
- See Photo 5 for set up.

Specimen	Unit Load (lbs.)	Time (min.)	Observation
1	258	15	No sudden and major changes.

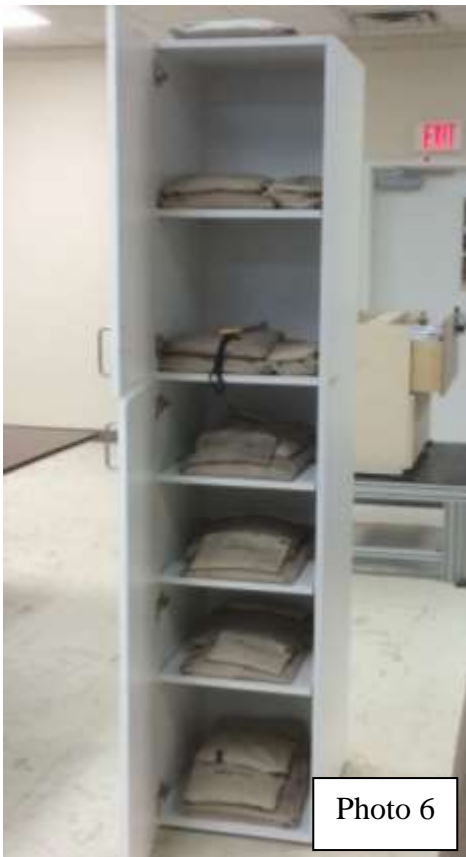
- Temperature / Humidity: 71⁰F / 41 RH%.
- Refer to page 3 for specified loads.
- The distributed proof load was evenly distributed along a line 8 inches in around the perimeter on the primary surface.
- All remaining surfaces were loaded with their distributed proof loads.
- Loads remained for 15 minutes.
- See Photo 6 for set up.

<u>Specimen</u>	<u>Unit Load (lbs.)</u>	<u>Time (min.)</u>	<u>Observation</u>
3	640	15	No sudden and major changes.

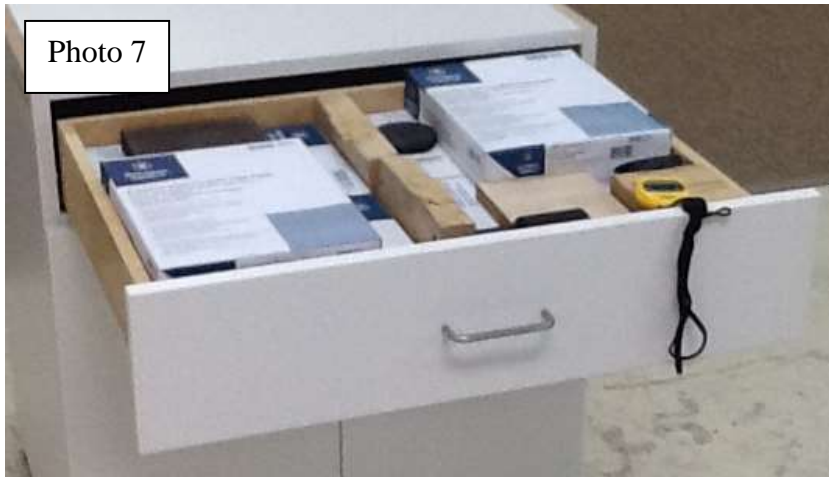
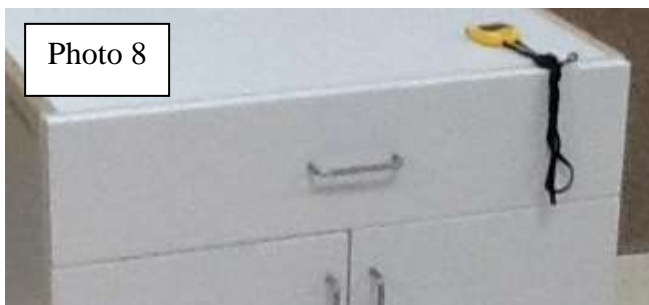
- Temperature / Humidity: 71⁰F / 40 RH%.
- Refer to page 3 for specified loads.
- The largest extendible element of each construction was loaded with its specified proof load and fully extended.
- Loads remained for 15 minutes.
- With the proof load still in the extendible element the drawers were fully closed and remained for an additional 15 minutes.
- See Photos 7 & 8 for set up.

Specimen	Segment	Time (min.)	Observation
2	Open	15	No sudden and major change to the structure of the unit.
	Closed	15	No sudden and major change to the structure of the unit.

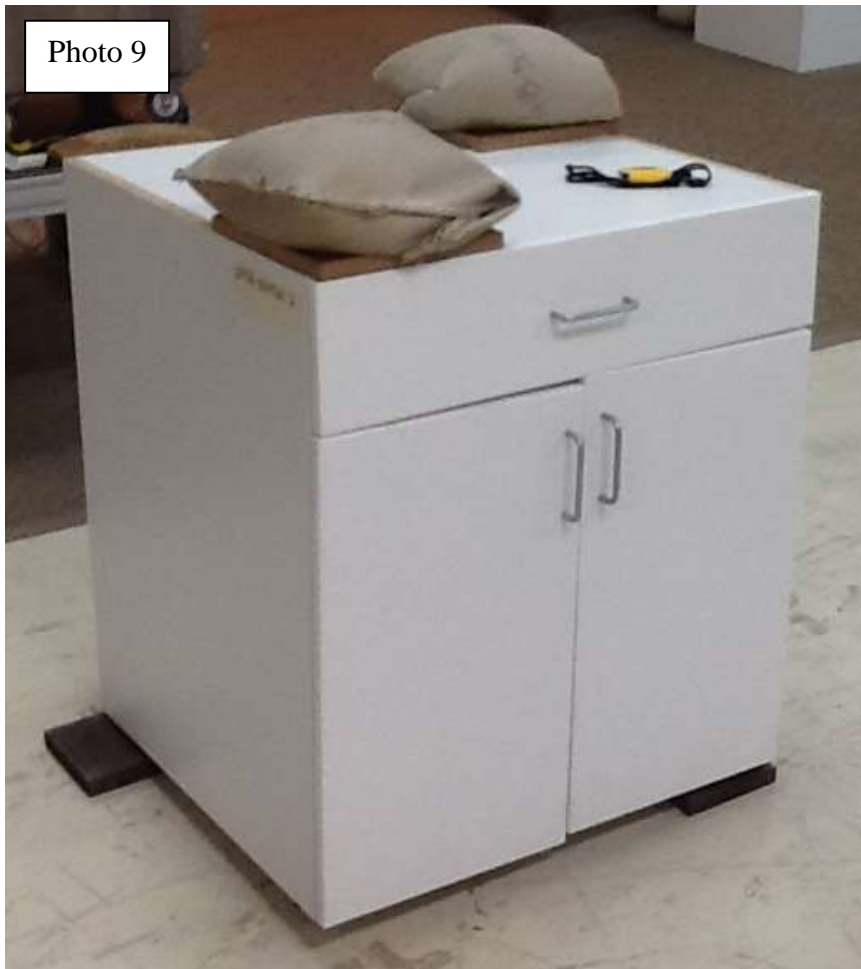
- Temperature / Humidity: 71°F / 40 RH%.
- Refer to page 3 for specified loads.
- Two 1 inch tall blocks were placed under the glides on opposite corners. The top two corners opposite the blocks under the glides were loaded with 50 lbs of weight each. The unit was loaded with its distributed functional load and was allowed to stand for 60 minutes.
- See Photo 9 for set up.

<u>Specimen</u>	<u>Time (min.)</u>	<u>Pull Force (lbs.)</u>	<u>Observation</u>
2	60	< 11.2	No loss of serviceability.

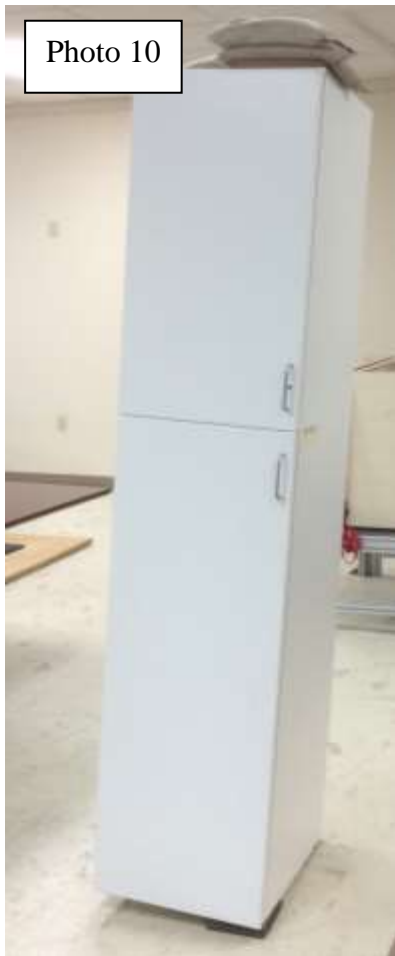
- Temperature / Humidity: 71⁰F / 41 RH%.
- Refer to page 3 for specified loads.
- Two 1 inch tall blocks were placed under the glides on opposite corners. The top two corners opposite the blocks under the glides were loaded with 50 lbs of weight each. The unit was loaded with its distributed functional load and was allowed to stand for 60 minutes.
- See Photo 10 for set up.

<u>Specimen</u>	<u>Time (min.)</u>	<u>Pull Force (lbs.)</u>	<u>Observation</u>
3	60	NA	No loss of serviceability.

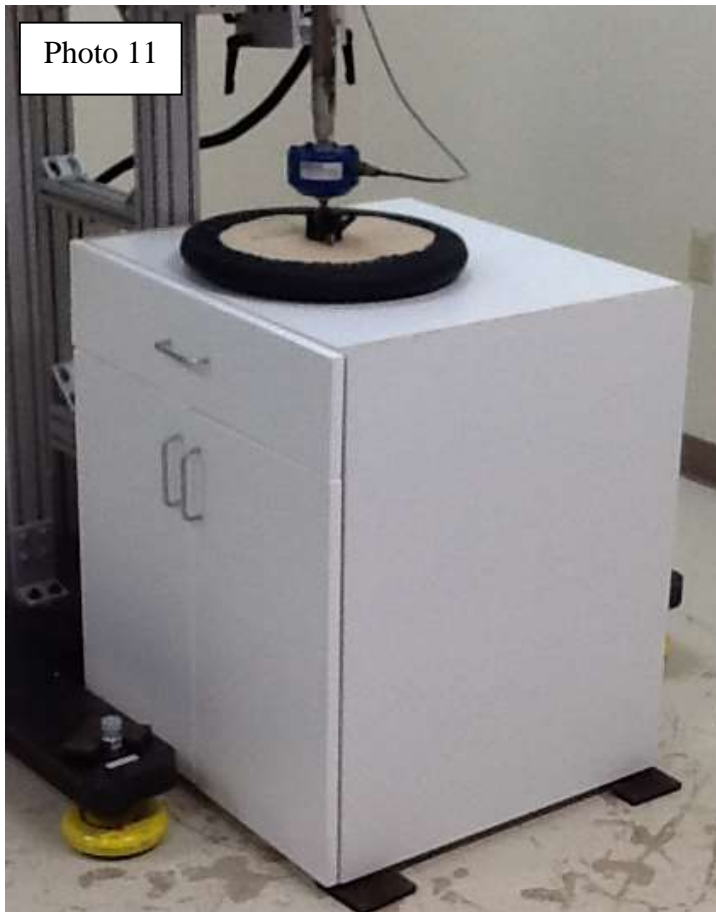
- Temperature / Humidity: 72^oF / 42 RH%.
- Refer to Page 3 for specified loads.
- Force applied: 200 lbs. 1 inch from the unit edge at the weakest location on the primary surface.
- All elements were loaded with their distributed functional loads and remained closed.
- Test rate: 14 cpm.
- See Photo 11 for set up.

Specimen	Load (lbs.)	Cycles	Pull Force (lbs.)	Observation
2	200	0	< 11.2	Test began.
	200	10,000	< 11.2	No loss of serviceability.

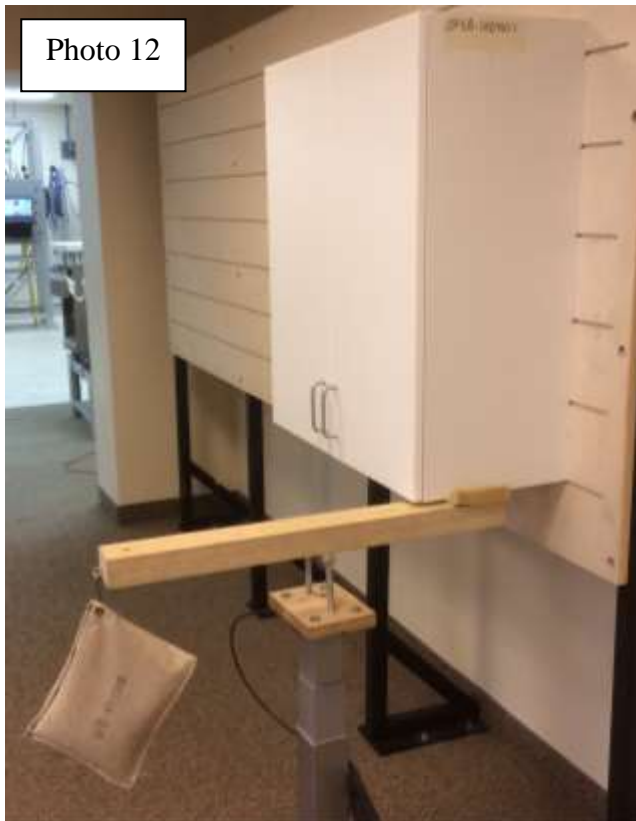
- Temperature / Humidity: 70⁰F / 28 RH%.
- A pivoting arm, in the horizontal position, was placed flush against the unit bottom, but not closer than 6 inches from the attachment point. A 10 lb weight was secured to the opposite side of the arm. The weighted side of the arm was then lifted 4 inches and released, allowing the opposing end to impact the underside of the unit.
- See Photo 12 for set up.

Specimen	Observation
1	No loss of serviceability.

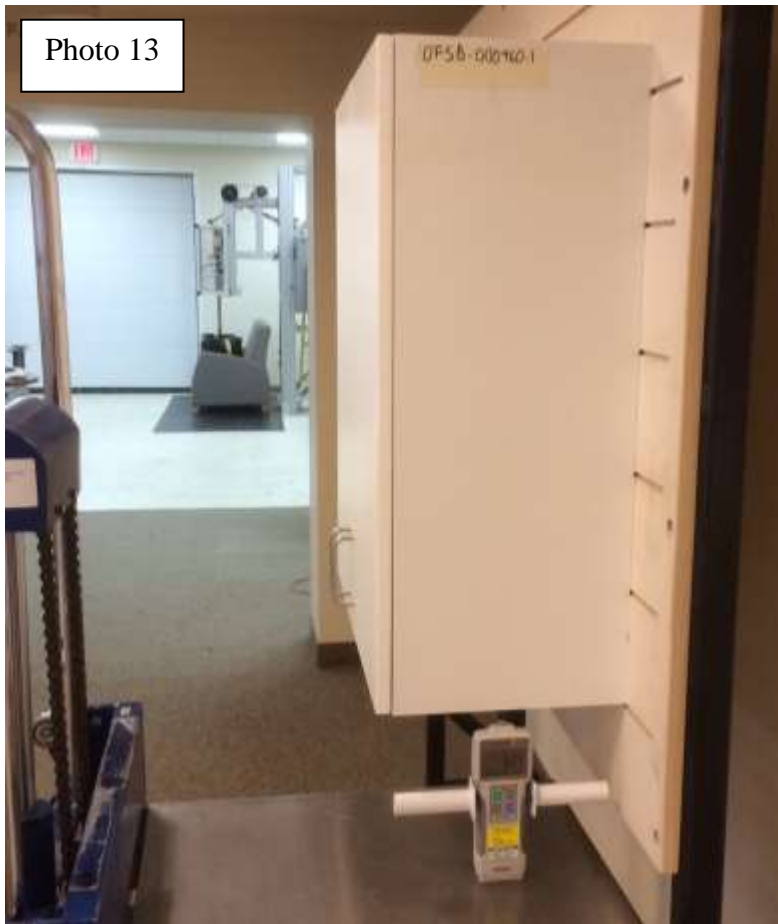
- Temperature / Humidity: 70⁰F / 28 RH%.
- A force was applied to one side of the unloaded unit at its center of balance until either the force reached 110 lbs, or the front edge of the unit became displaced 2 inches.
- See Photo 13 for set up.

Specimen	Force (lbs.)	Observation
1	110	The unit did not become disengaged. No loss of serviceability occurred.

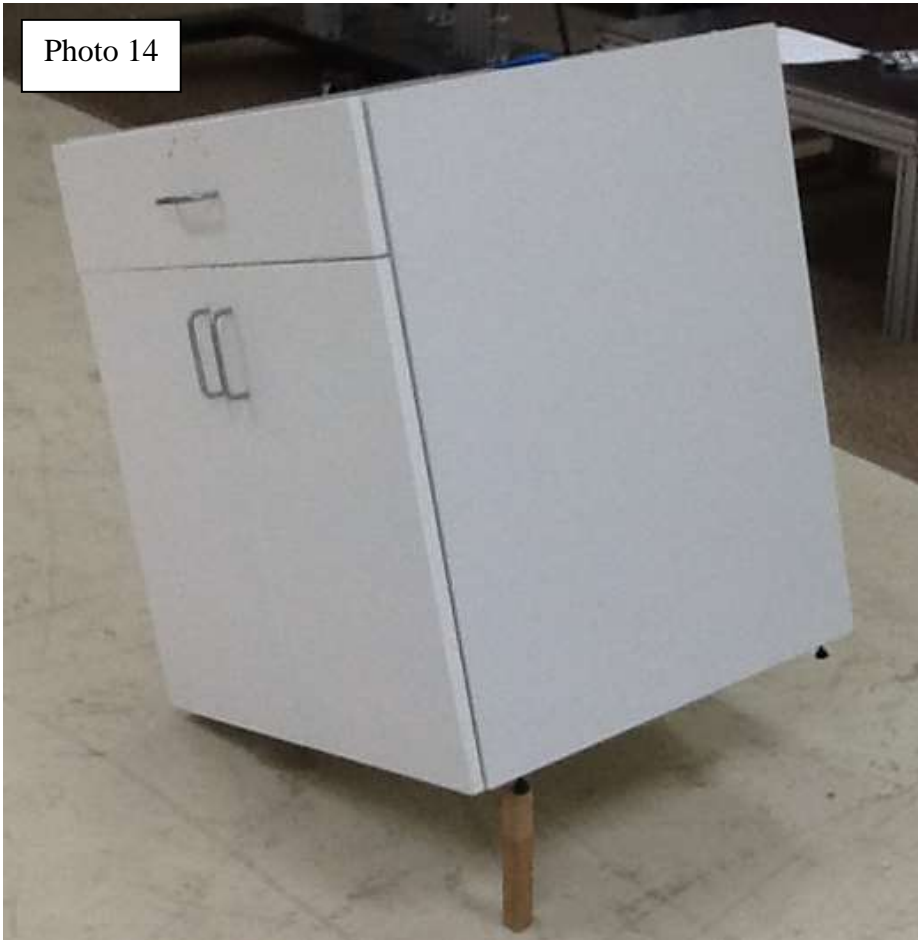
- Temperature / Humidity: 71⁰F / 42 RH%.
- Unit weight: 99.45 lbs.
- Drop height: 7.1 inches.
- Each side of the unit was allowed to fall freely from the specified height.
- See Photo 14 for set up.

Specimen	Segment	Height (in.)	Pull Force (lbs.)	Observation
2	Left	7.1	< 11.2	No loss of serviceability.
	Right	7.1	< 11.2	No loss of serviceability.

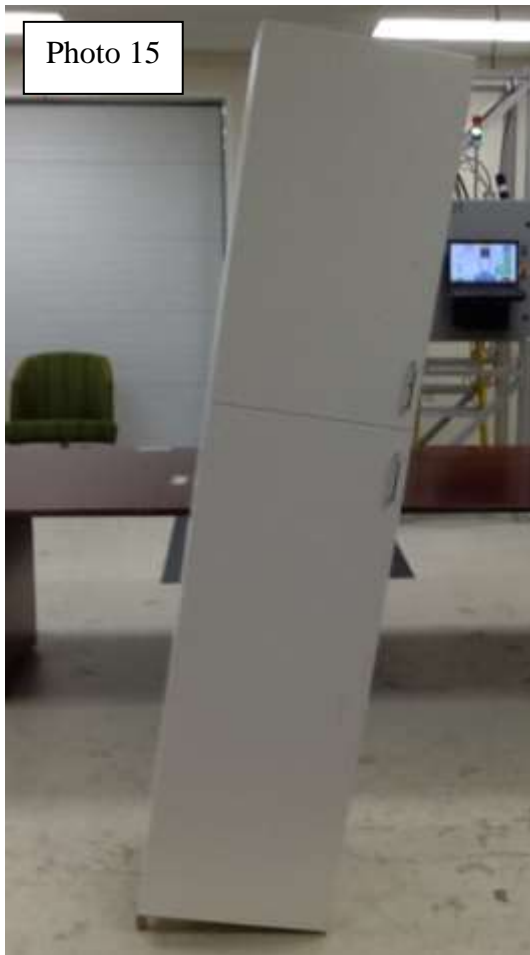
- Temperature / Humidity: 71⁰F / 41 RH%.
- Unit weight: 139.90 lbs.
- Drop height: Tipping point - 3.5 inches.
- Each side of the unit was allowed to fall freely from the specified height.
- See Photo 15 for set up.

Specimen	Segment	Height (in.)	Pull Force (lbs.)	Observation
3	Left	3.5	NA	No loss of serviceability.
	Right	3.5	NA	No loss of serviceability.

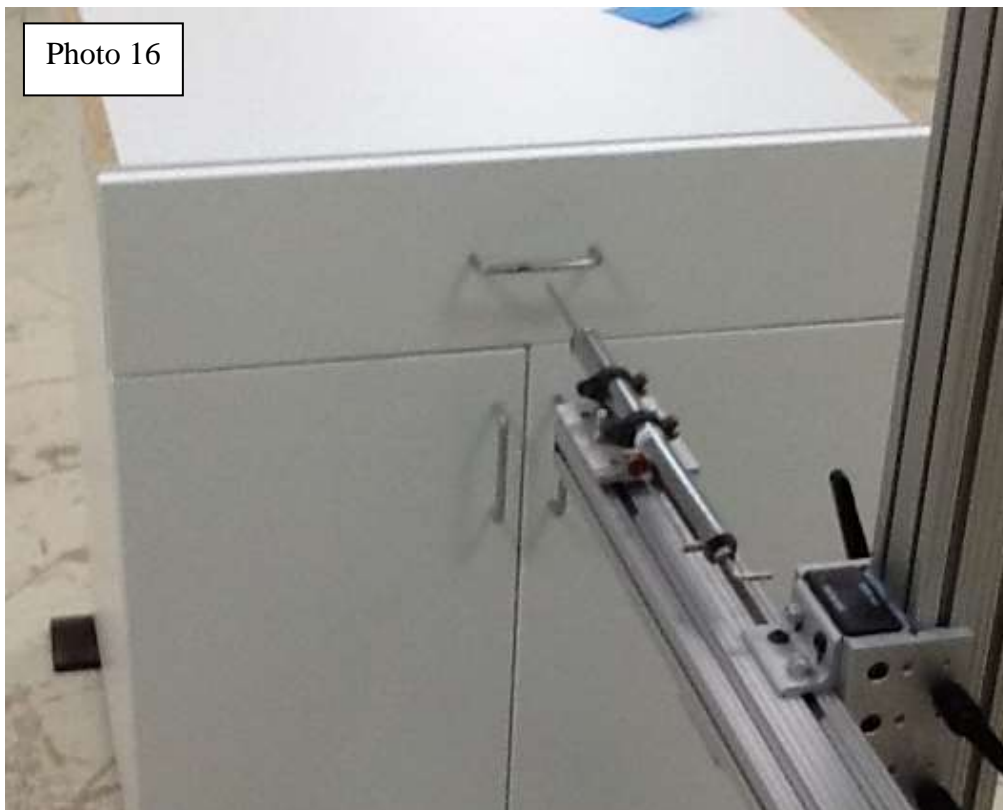
- Temperature / Humidity: 70⁰F / 38 RH%.
- Refer to page 3 for specified loads.
- The drawer being tested was loaded with its functional load. A spring force gauge was set 2.0 inches away from the drawer front. The drawer was pushed against the force gauge with the amount of weight loaded in the drawer, but not to exceed 40 lbs. The drawer was released and the at rest position was recorded for all five cycles.
- See Photo 16 for set up.

Specimen	Load (lbs.)	Max. at Rest (in.)	Observation
2	33	< 1.5	No loss of serviceability.

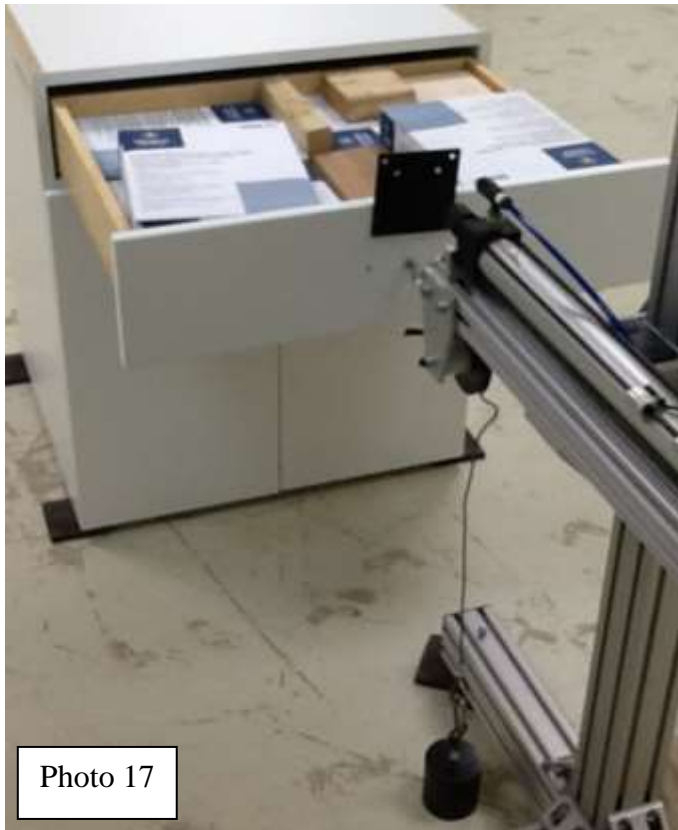
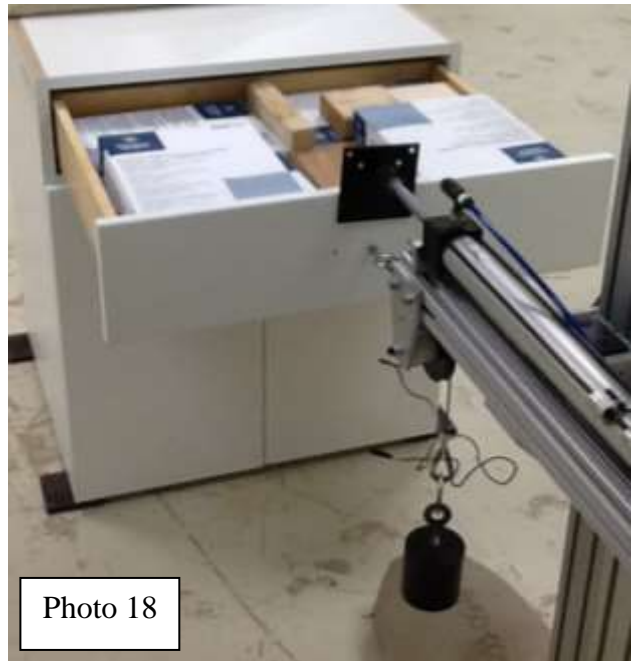
- Temperature / Humidity: 70 - 72°F / 34 - 38 RH%.
- Refer to page 3 for the specified loads.
- A cable was attached to the center of the drawer front and extended over a pulley. The appropriate amount of weight was attached to the opposite end of the cable. The drawer was opened 1.5 inches from fully closed and released, allowing the out stops to be impacted. The drawer was then opened 2.0 inches from fully opened and released for the duration of the test.
- Test rate: 18 – 19 cpm.
- See Photos 17 & 18 for set up.

Specimen	Segment	Cycles	Pull Force (lbs.)	Observation
2	Box	5	< 11.2	No loss of serviceability.
		0	< 11.2	Test began.
		15,000	< 11.2	No loss of serviceability.

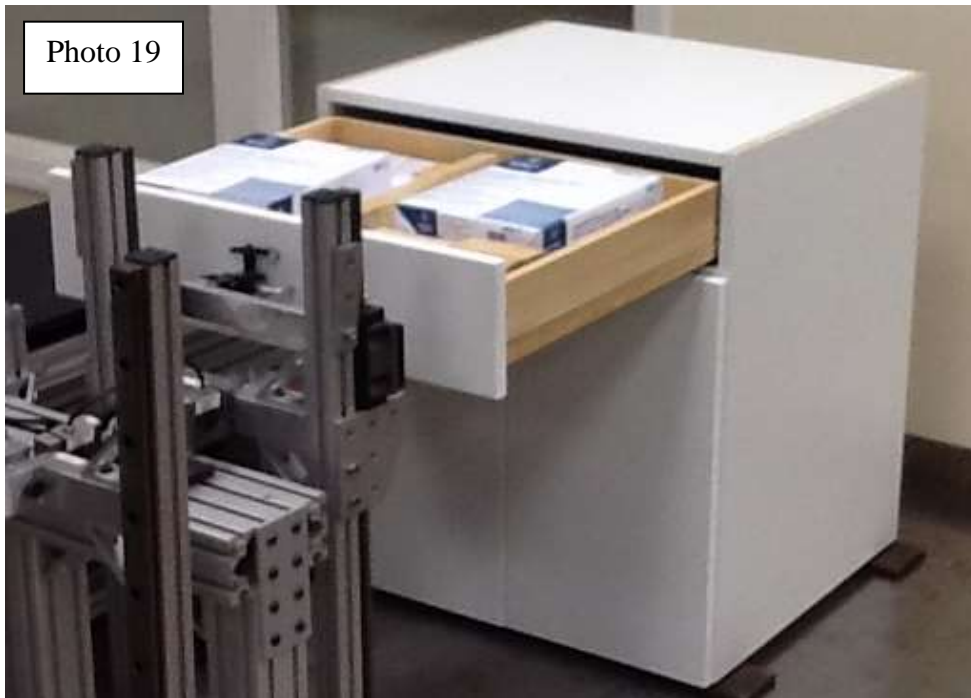
- Temperature / Humidity: 71 - 73⁰F / 35 - 42 RH%.
- Refer to page 3 for specified loads.
- The drawer being tested was loaded with its distributed functional load. A restraining device was attached to the center of the drawer pull area and cycled for 50,000 cycles.
- Test rate: 8 – 9 cpm.
- See Photo 19 for set up.

Specimen	Segment	Cycles	Pull Force (lbs.)	Observation
2	Center	0	< 11.2	Test began.
		50,000	< 11.2	No loss of serviceability.

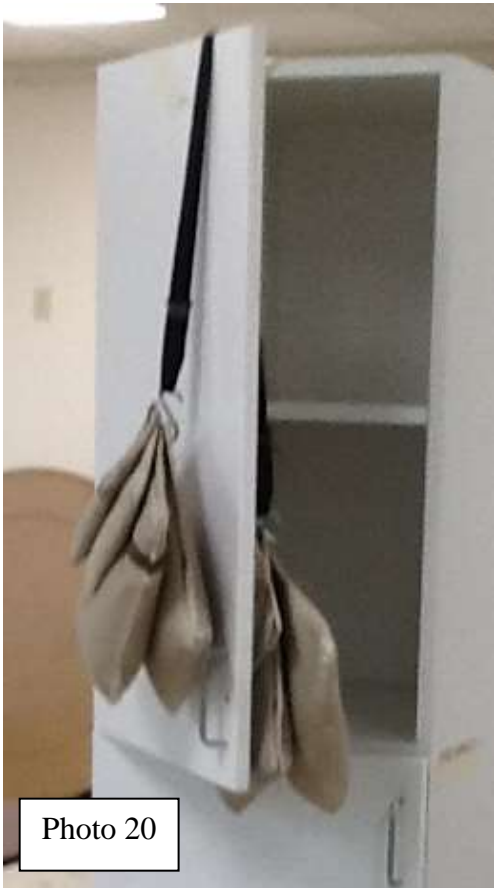
- Temperature / Humidity: 71°F / 40 RH%.
- 44 lbs was suspended 4 inches from the outside edge of the door. The door was then cycled 10 times from 45 degrees from fully closed to 10 degrees from fully opened.
- See Photo 20 for set up.

Specimen	Load (lbs.)	Cycles	Observation
3	44	10	No loss of serviceability.

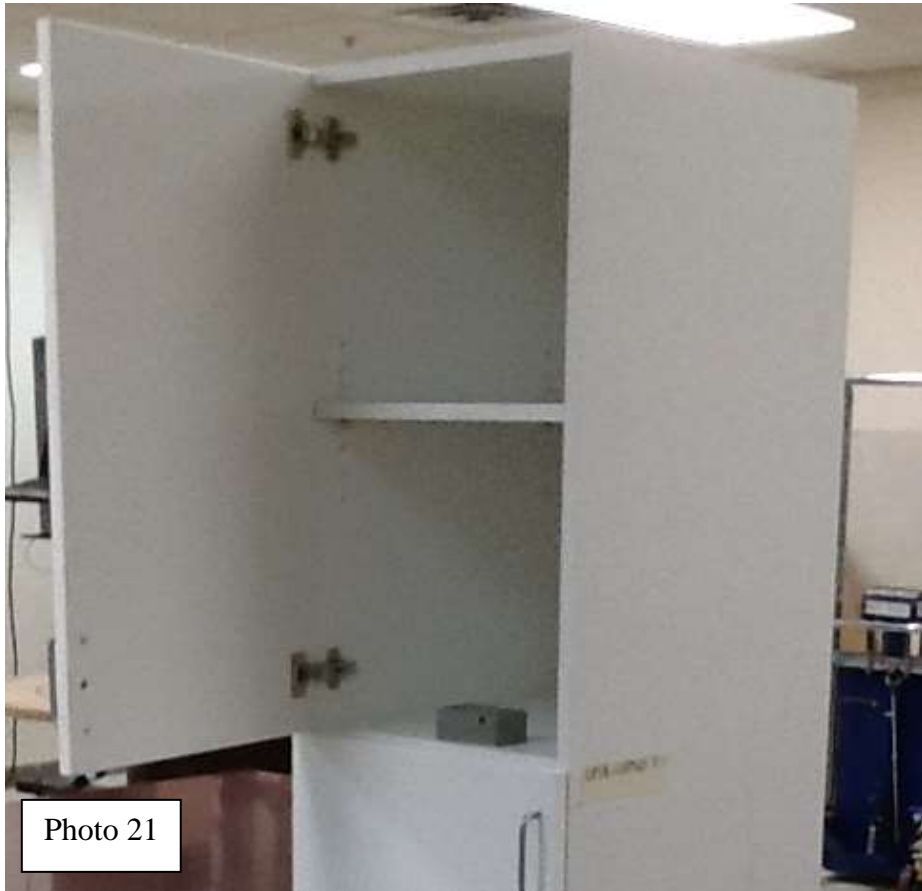
- Temperature / Humidity: 71°F / 40 RH%.
- 13.5 lbs of force was applied to the center of the door, 4 inches in from the outside edge.
- See Photo 21 for set up.

Specimen	Load (lbs.)	Observation
3	> 13.5	No loss of serviceability.

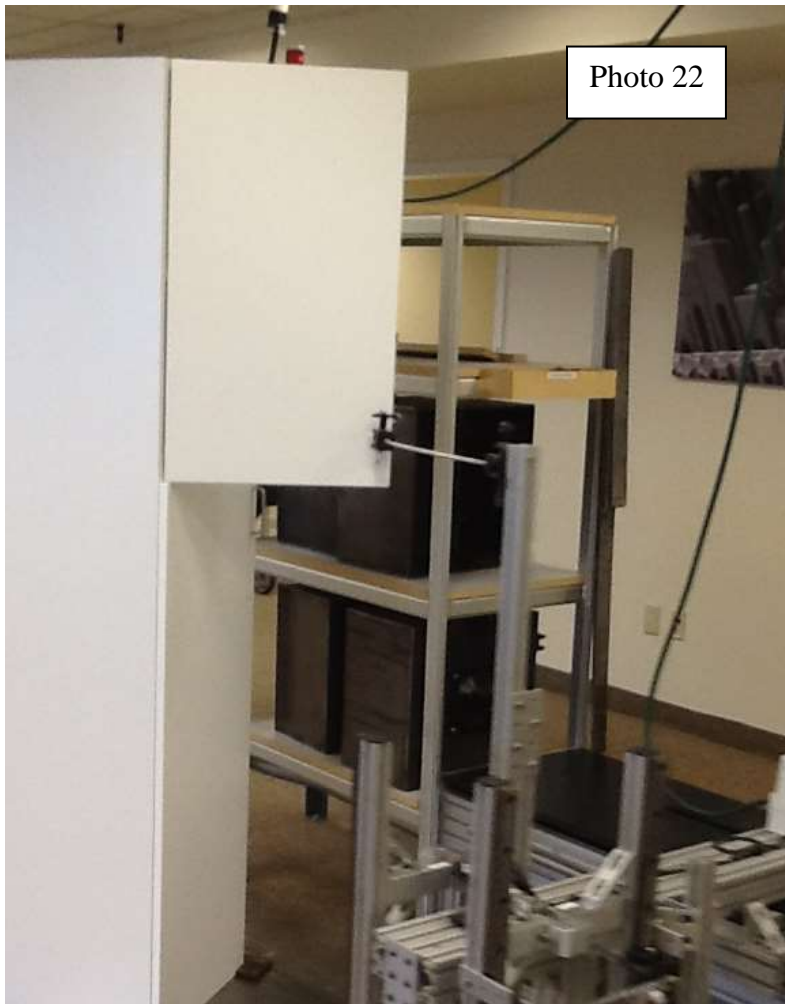
- Temperature / Humidity: 70°F / 30 RH%.
- The door was cycled from 10 degrees from fully closed to 10 degrees from fully opened and back. The door was cycled for 20,000 cycles at the center of the pull area.
- Test rate: 13 cpm.
- See Photo 22 for set up.

<u>Specimen</u>	<u>Segment</u>	<u>Cycles</u>	<u>Observation</u>
3	Center	0	Test began.
		20,000	No loss of serviceability.

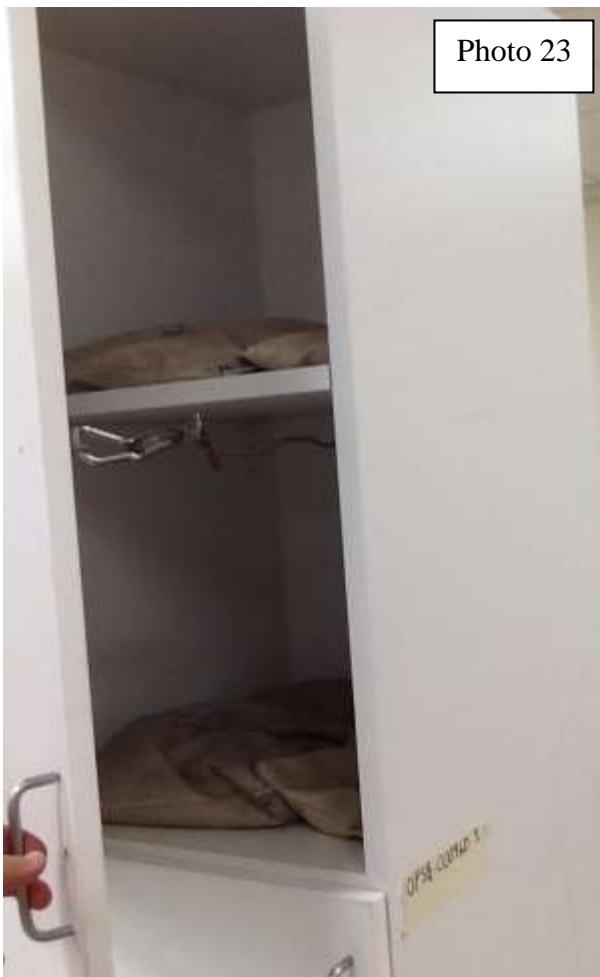
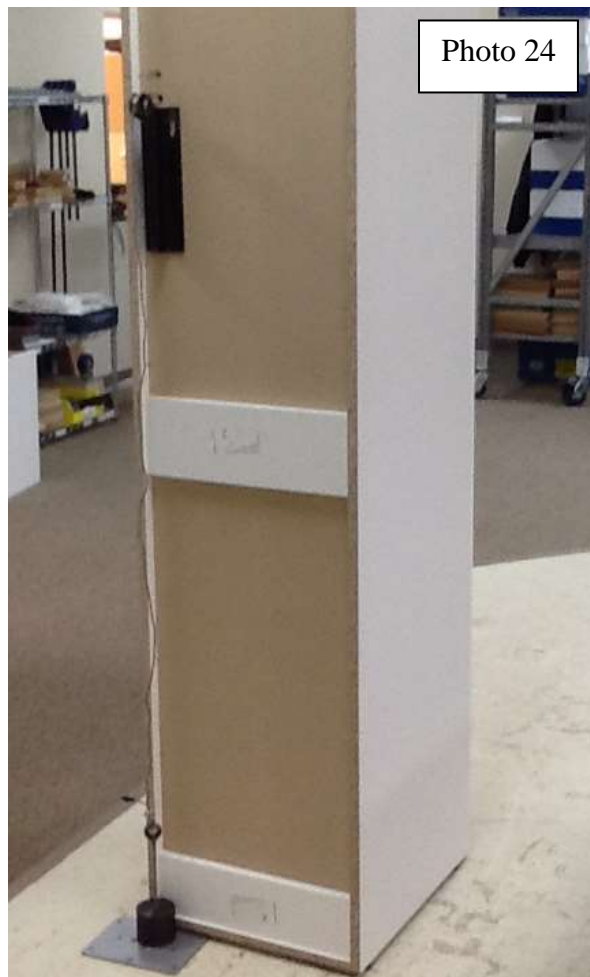
- Temperature / Humidity: 71°F / 40 RH%.
- Refer to page 3 for specified loads.
- The door shelves were loaded with their distributed functional loads.
- A cable was attached to the center of the door, opposite the hinge. The cable was extended through the back of the unit over a pulley and the appropriate amount of weight was attached to the opposite end of the cable. The door was then open 30 degrees and released, allowing the door to slam shut.
- See Photos 23 & 24 for set up.

Specimen	Cycles	Observation
3	10	No loss of serviceability.

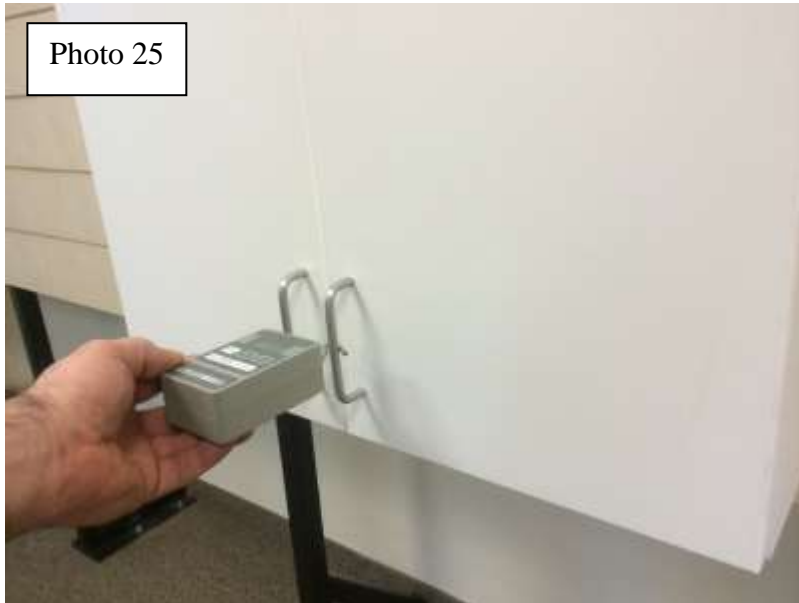
- Temperature / Humidity: 71⁰F / 32 RH%.
- Using a force gauge, the door was pulled from all the way closed to all the way open.
- See Photo 25 for set up.

Specimen	Segment	Pull Force (lbs.)	Observation
1	Door	< 11.2	The force required to pull the door from all the way closed to all the way open did not exceed 11.2 lbs.

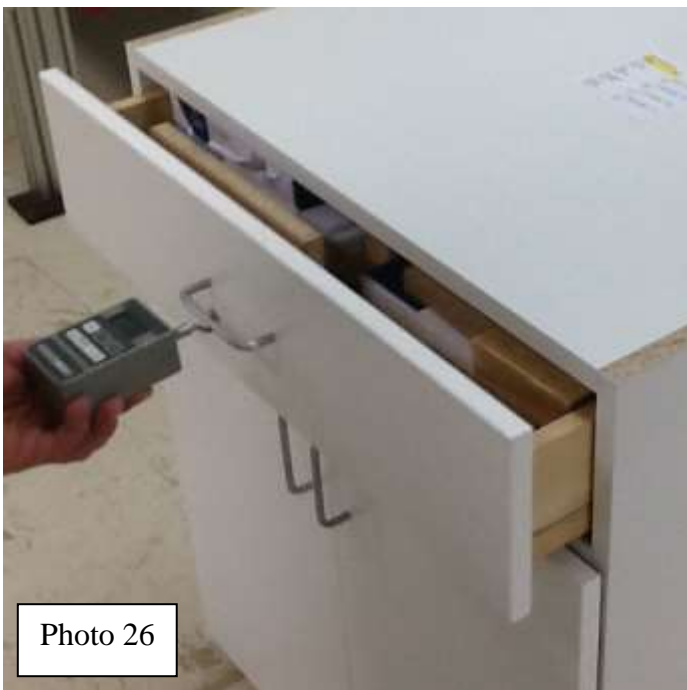
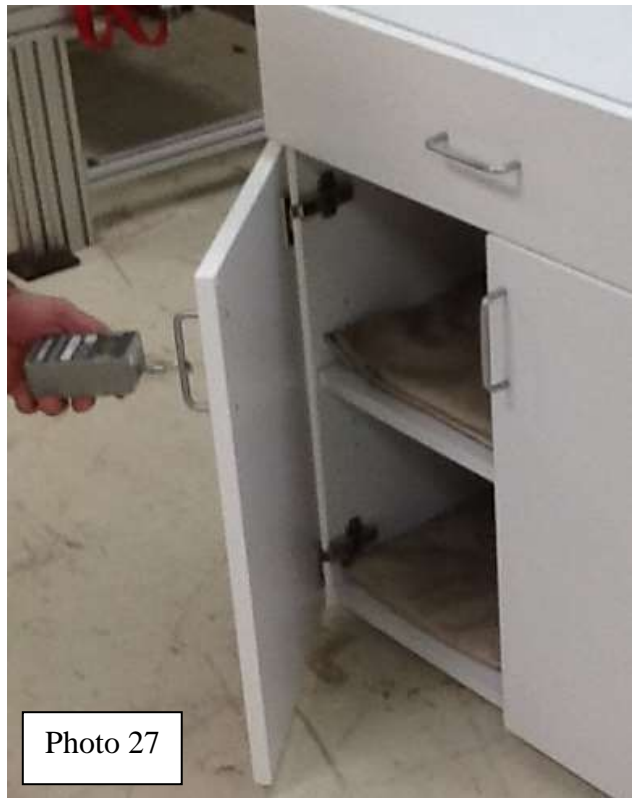
- Temperature / Humidity: 71°F / 40 RH%.
- Refer to page 3 for specified loads.
- Extendible elements were loaded with their distributed functional loads.
- Using a force gauge, the extendible element was pulled from all the way closed to all the way open.
- See Photos 26 & 27 for set up.

Specimen	Segment	Pull Force (lbs.)	Observation
2	Drawer	< 11.2	The force required to pull the drawer from all the way closed to all the way open did not exceed 11.2 lbs.
	Door	< 11.2	The force required to pull the door from all the way closed to all the way open did not exceed 11.2 lbs.

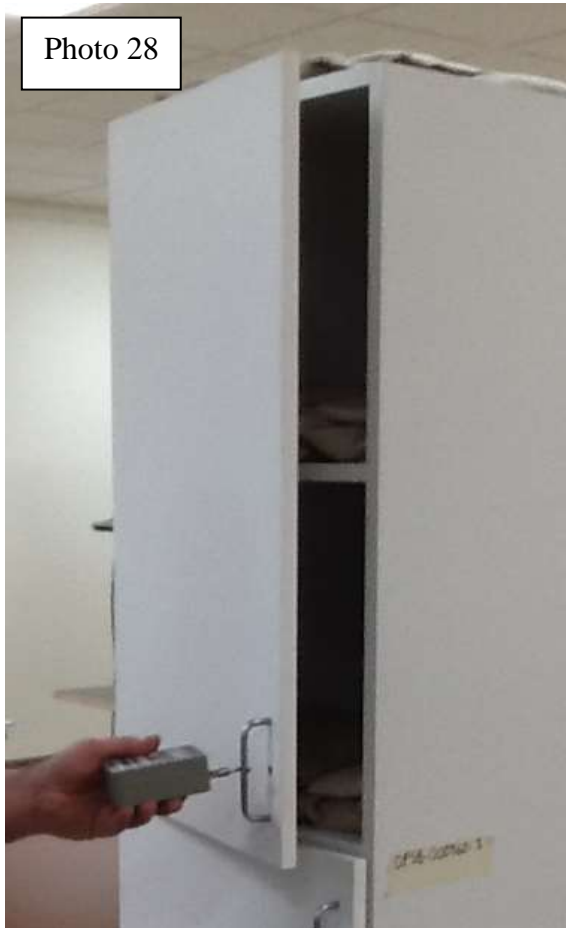
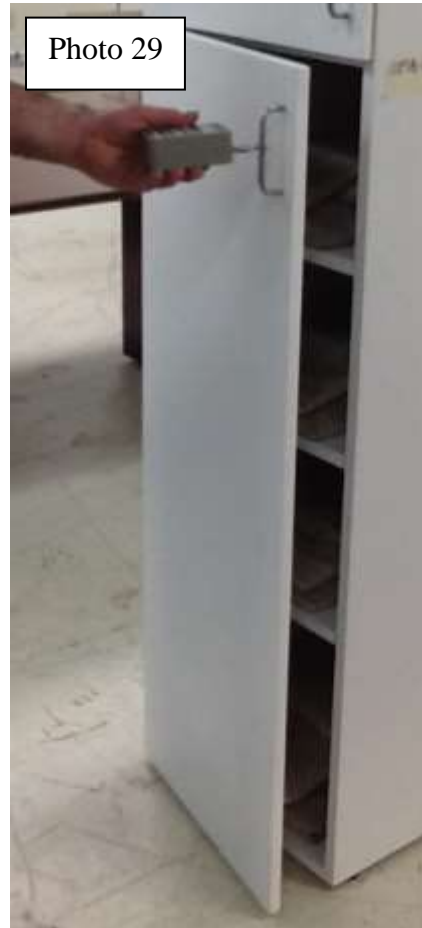
- Temperature / Humidity: 71⁰F / 41 RH%.
- Using a force gauge, the door was pulled from all the way closed to all the way open.
- See Photos 28 & 29 for set up.

Specimen	Segment	Pull Force (lbs.)	Observation
3	Doors	< 11.2	The force required to pull the door from all the way closed to all the way open did not exceed 11.2 lbs.

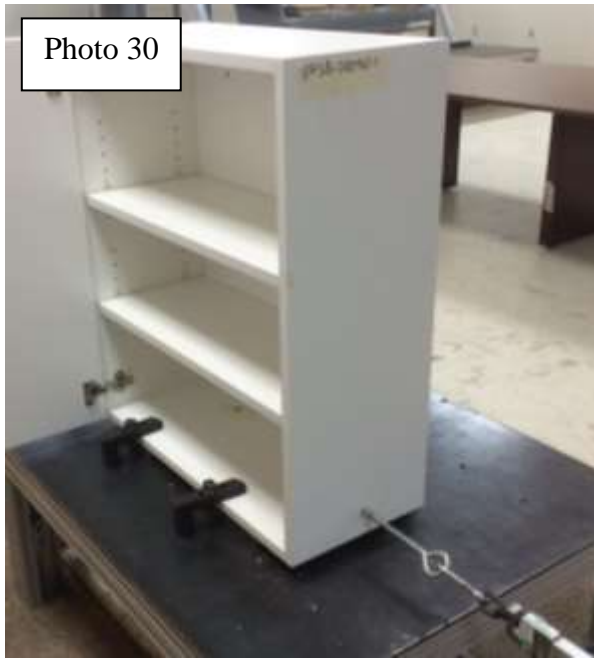
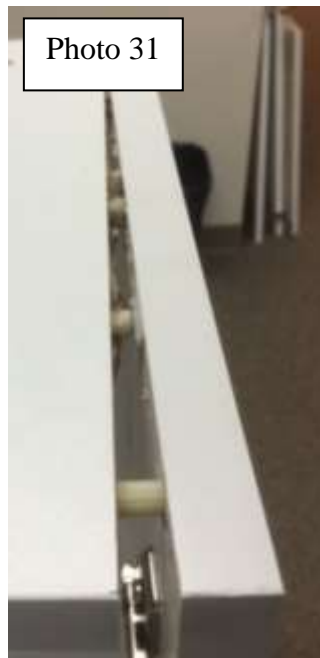
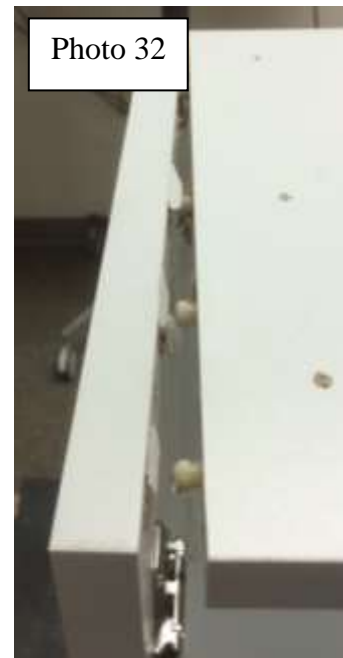
- Temperature / Humidity: 71⁰F / 38 RH%.
- A horizontal, outward force was applied to the end panel until the panel became disconnected from the cabinet.
- See Photo 30 for set up and Photos 31 & 32 for failure.

Specimen	Segment	Pull Force (lbs.)	Observation
1	Side 1	350	The force required to pull the end panel from the cabinet reached 350 lbs.
	Side 2	410	The force required to pull the end panel from the cabinet reached 410 lbs.

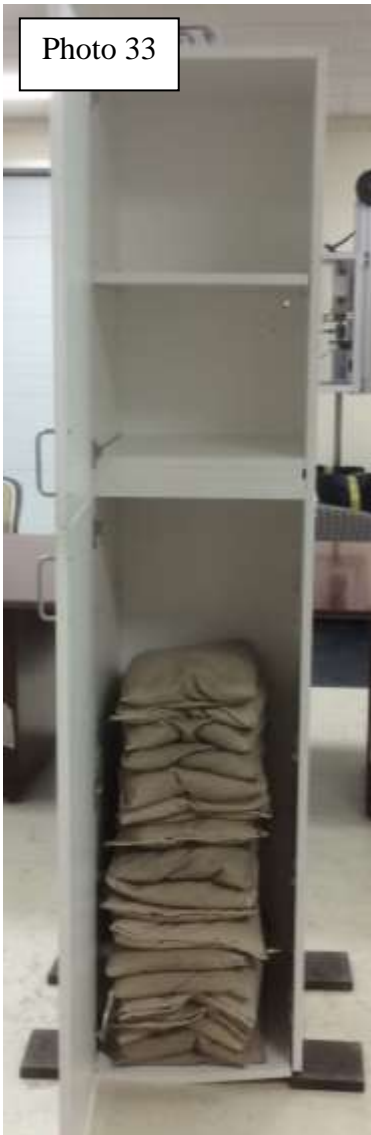
Photo 33

- Temperature / Humidity: 71°F / 39 RH%.
- Per BIFMA, the maximum proof load required for this sized bottom shelf is 153 lbs.
- For this test, the bottom was loaded with weight until failure occurred.
- See Photos 33, 34, & 35.

Specimen	Load (lbs.)	Observation
3	900	No sudden and major changes.
	950	Failure occurred
